4.0 Durango, Colorado, Disposal Site

Figure 4-1. 2004 Annual Compliance Drawing for the Durango, Colorado, Disposal Site

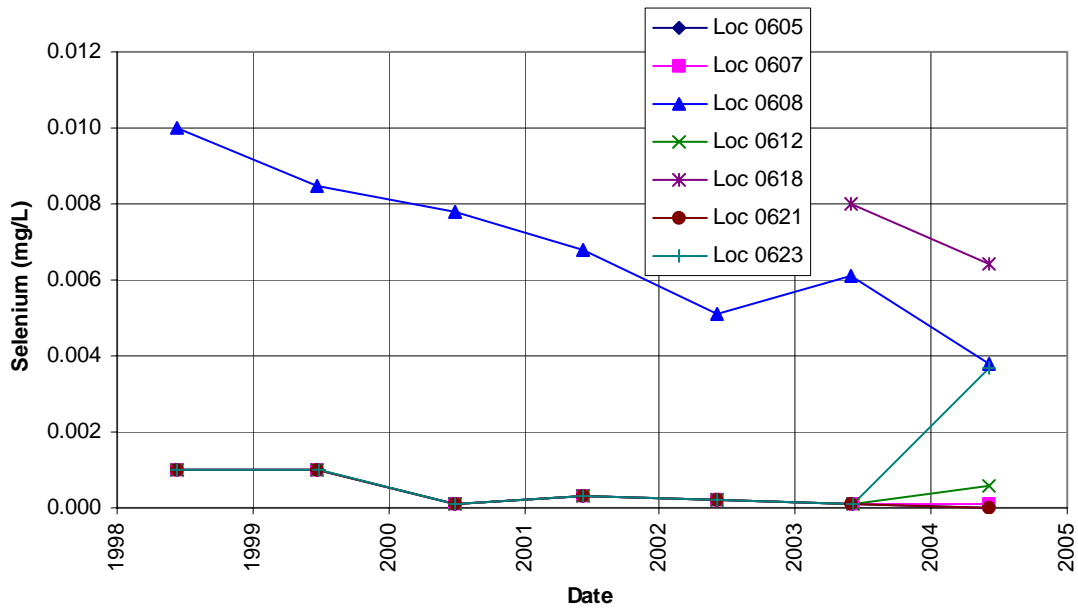
Figure 4-2. Time-Concentration Plots of Selenium in Ground Water at the Durango, Colorado, Disposal Site

4D With the exception of the uranium concentration in MW-0618, the results of monitoring in 2004 were consistent with previous years. Concentrations of all three indicator analytes were below their respective MCLs, and most results were less than detection limits or minimum detectable activity. Time versus concentration plots for selenium and uranium are included as Figures 4-2 and 4-3. Concentrations of molybdenum were less than 0.001 mg/L.

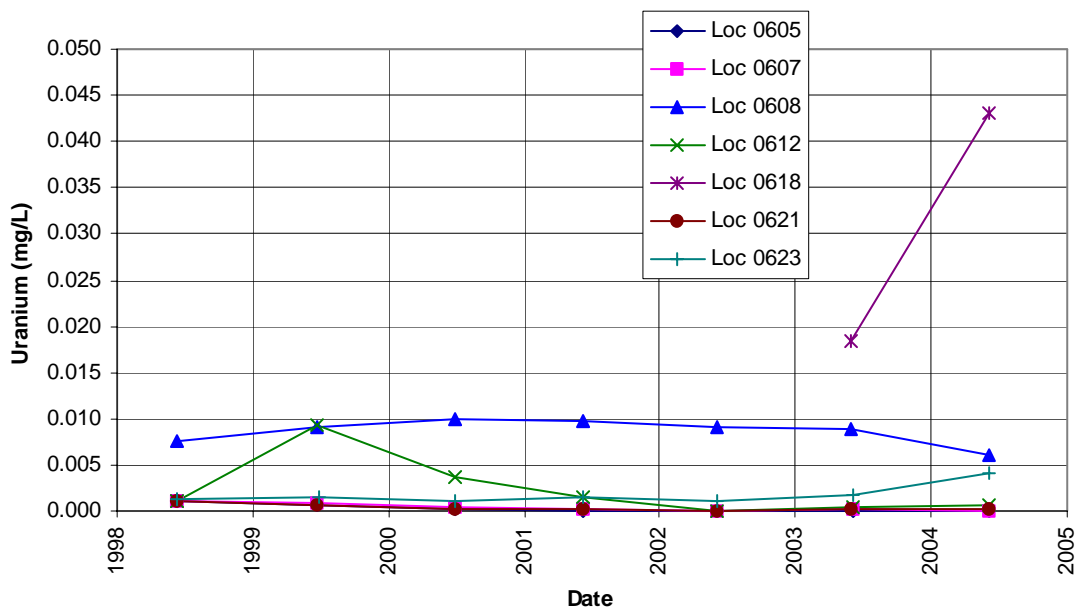
Figure 4-3. Time-Concentration Plots of Uranium in Ground Water at the Durango, Colorado, Disposal Site

The uranium concentration in monitor well MW-0618 increased substantially in 2004, the second annual sampling event for that well. The concentration in 2004 was 0.043 mg/L, which is just below its MCL. DOE is in the process of evaluating the cause of increasing uranium concentrations in this well. Monitoring frequency has been increased for MW-0618 to determine if there are any trends in uranium concentration in the well that can be correlated with closure of the collection drain system.

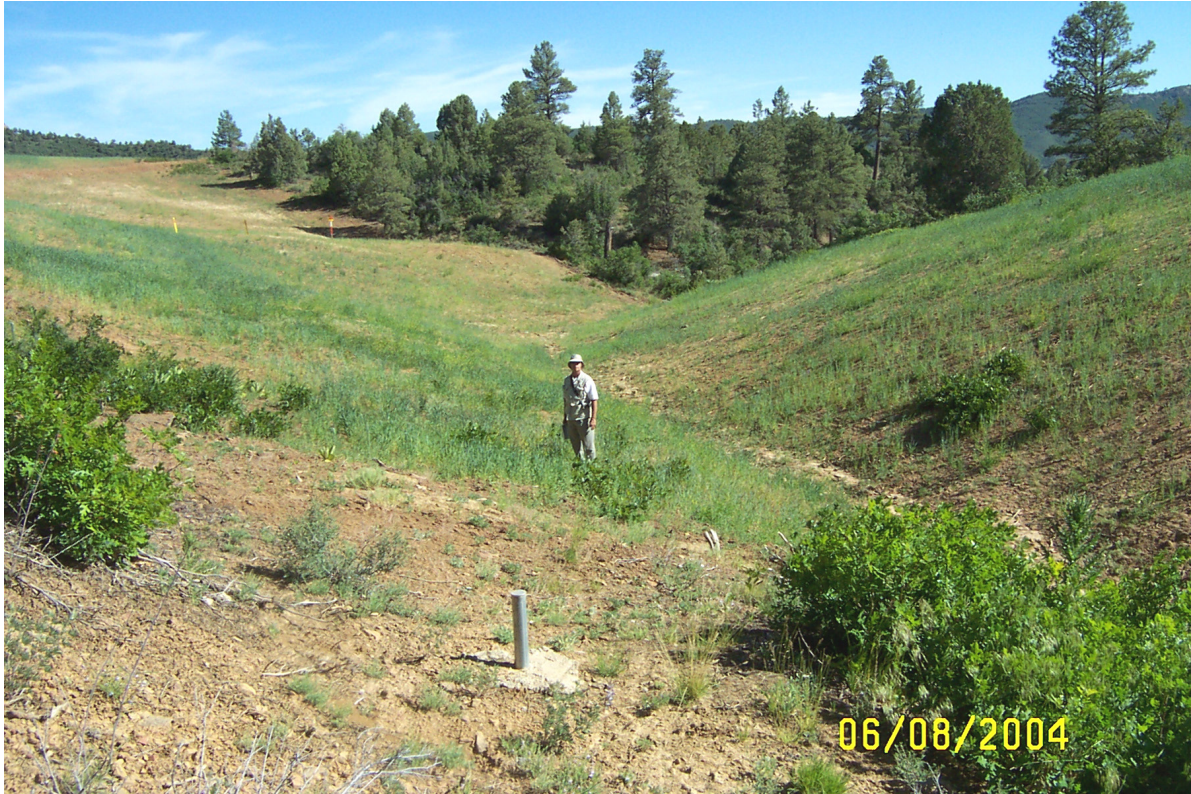
Site Markers, Survey and Boundary Monuments—Site markers and survey monuments were in good to excellent condition. The site marker near the entrance gate (SMK-1) has been slightly damaged by bullets; however, it was legible and in generally good condition. Boundary monument BM-6, located at the southwest corner of the site, was missing and presumably was destroyed during pipeline construction associated with the reservoir project (PL-1). The monument will not be replaced because two witness monuments at that property corner are intact. The remaining boundary monuments were intact and generally in good condition.

DUR 6/2004. PL-1. Inspector marks the location of missing boundary monument BM-6; the north witness corner is in the foreground.

Construction of a new reservoir is occurring south and west of the disposal site. Heavy construction traffic is present on the county road that crosses the southwest corner of the site. A boundary monument was destroyed during pipeline construction activities adjacent to the site. The monument will not be replaced because two witness monuments at that property corner are intact. Recreational use of the area is expected to increase substantially upon completion of the reservoir project, and evidence of trespassing and vandalism will continue to be monitored.

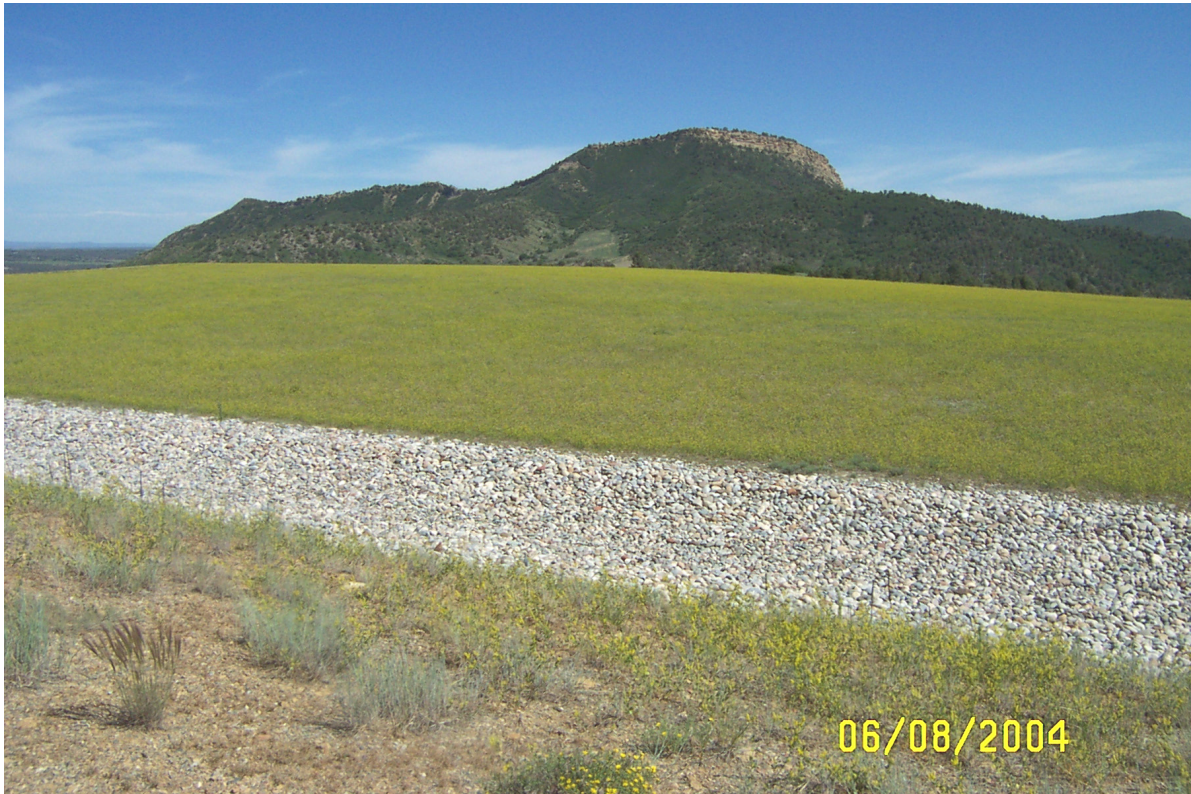
Vegetation on top of the cell was in good condition (PL-2). The vegetation consisted of seeded grasses and several volunteer species including deep-rooted shrubs. No woody species of trees and shrubs were found on the cell top during the 2004 inspection; the LTSP requires removal of these plants from the disposal cell (top and side slopes) when they exceed 3.5 feet in height. Noxious weeds were found on the cell top and herbicide was applied during the spring, summer, and fall.

DUR 6/2004. PL-2. Healthy vegetation on the disposal cell top.
