4.0 Durango, Colorado, Disposal Site

Figure 4-1. 2004 Annual Compliance Drawing for the Durango, Colorado, Disposal Site

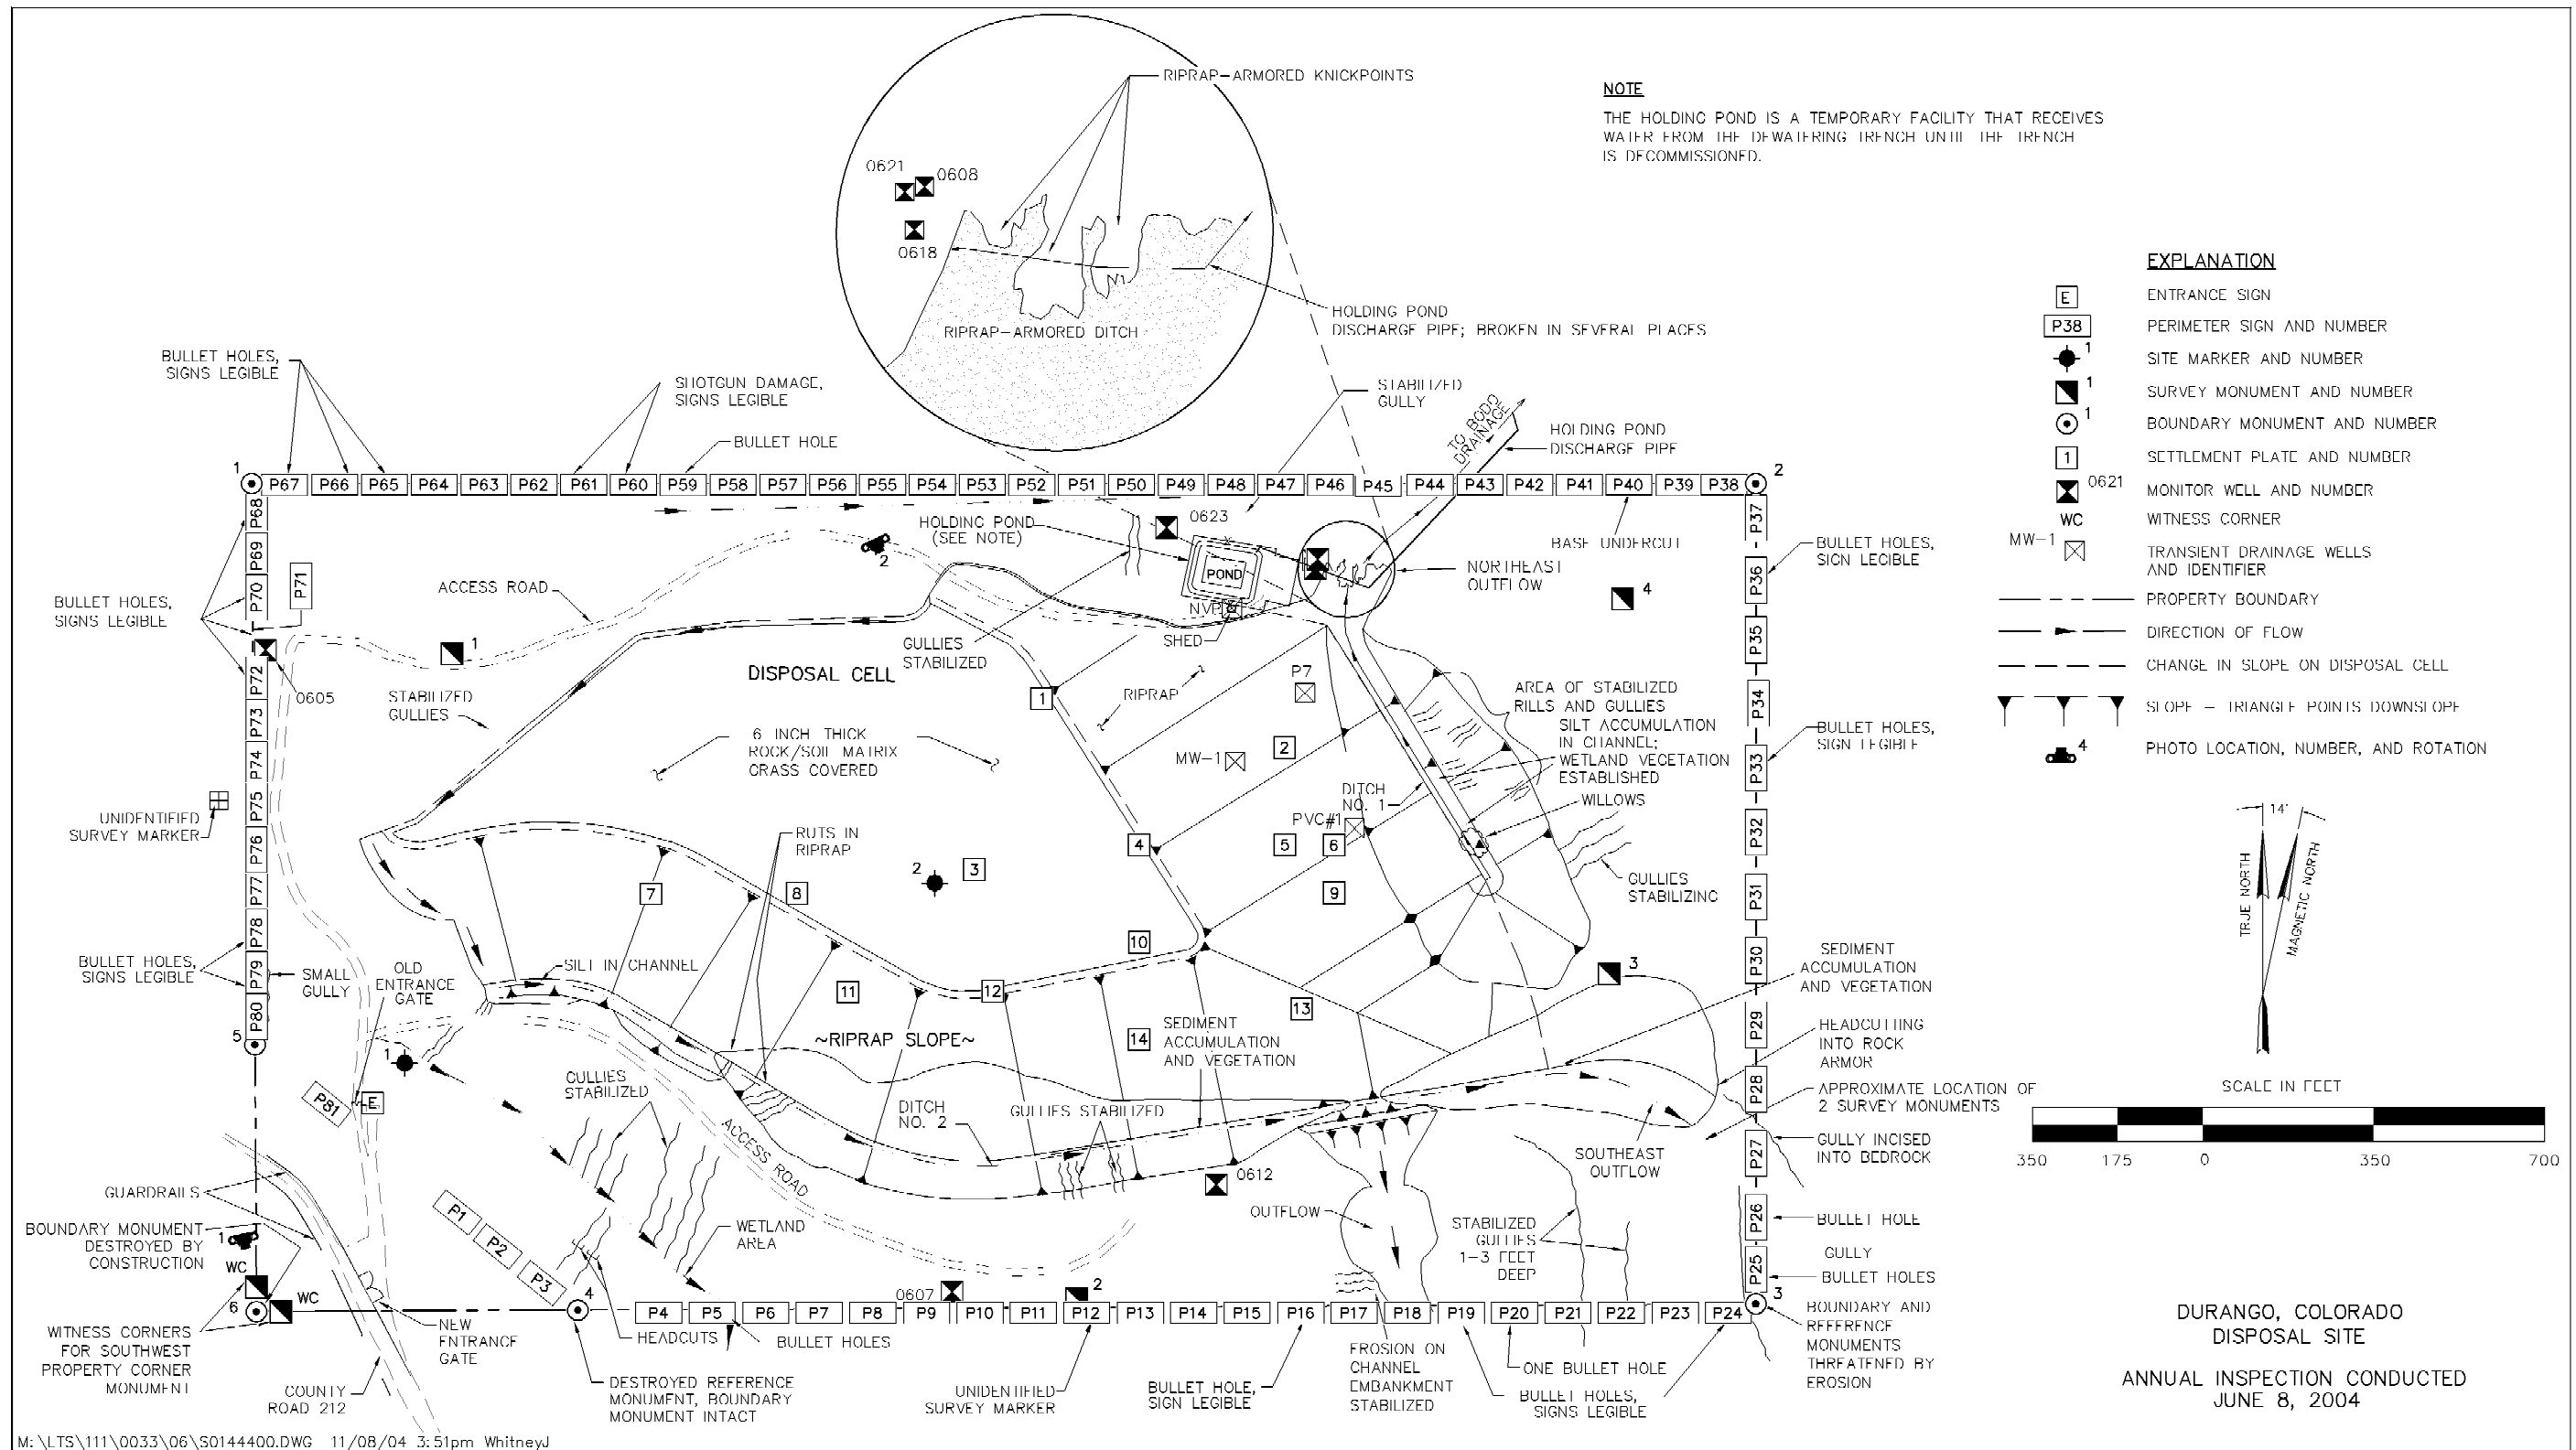
The site, located southwest of Durango, Colorado, was inspected on June 8, 2004. Results of the inspection are described below. Features and photograph locations (PLs) discussed in this report are shown on Figure 4-1. Numbers in the left margin of this report refer to items summarized in the Executive Summary table.
